Architectural Heritage Impact Assessment

Former Bank of Ireland
Building , Market Street,
Cootehill
June 2024

craftstudio
architecture

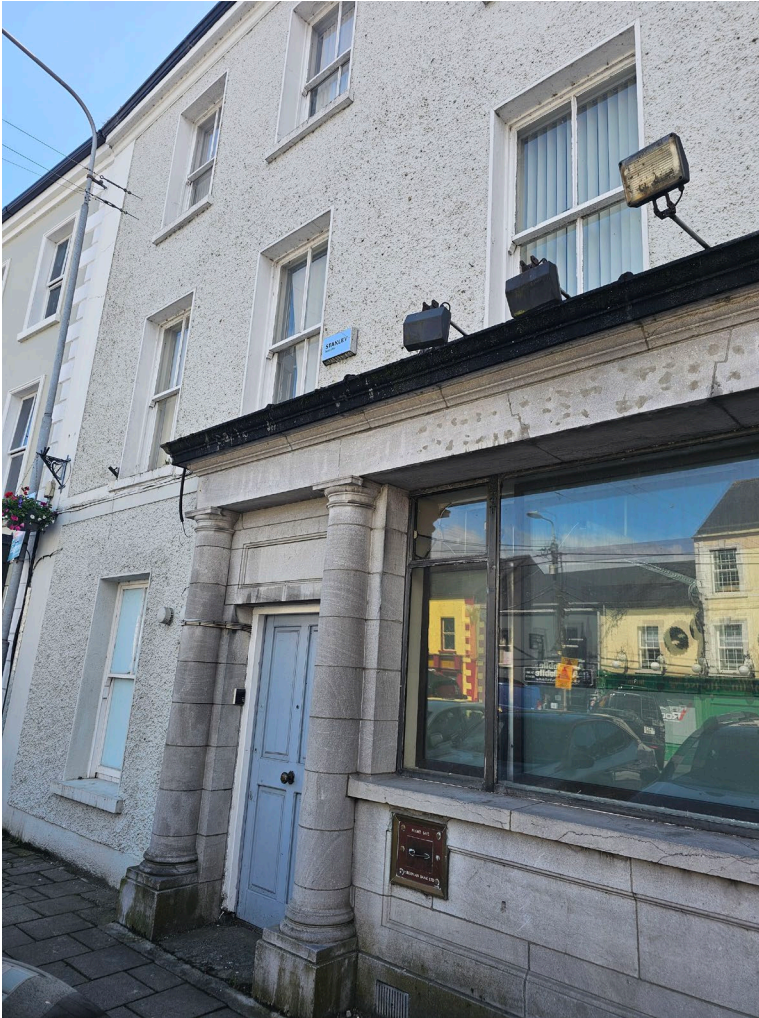
Fig. 1 - Front Elevation of Building

The former Bank is an impressive four bay three-storey former house, with bank front later inserted to the ground floor. The buildings front elevation and south gable with chimney are it's most prominent feature from the street scape, both of which are only being subjected only to localized repair and will remain as is. Three-bay limestone bank front to ground floor with engaged doric columns on plinths flanking door openings at either end and supporting plain entablature are in good condition and will be subject to localised cleaning. Four panelled doors with raised and fielded panels having overlight to bank entrance to remain, subject to localised repair and repainting. Square headed timber sliding sash windows on the front façade, two over two pane, exhibit small amounts of localised damage and will also be subject to repair.

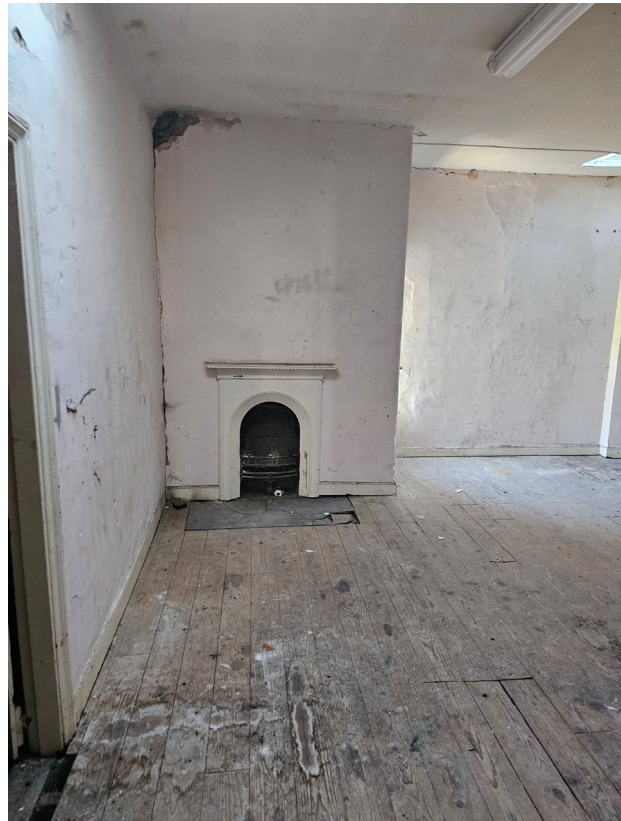
Fig.20 – Interior View of Third Floor

The third floor is accessed via a service staircase. This level shows significant deterioration owing to water ingress and neglect. It is not proposed to occupy this space as habitable accommodation as part of the proposed works.
